EXECUTIVE SUMMARY (10 pts)

The project consisted of reconstructing Runway 18-36 and connecting taxiways (164,000 SY), relocation of NAVAIDS, two new aircraft arresting barriers, storm sewer, edge lighting, in-pavement lighting, and perimeter roads.

PROJECT SCHEDULE AND SCOPE (5 pts)

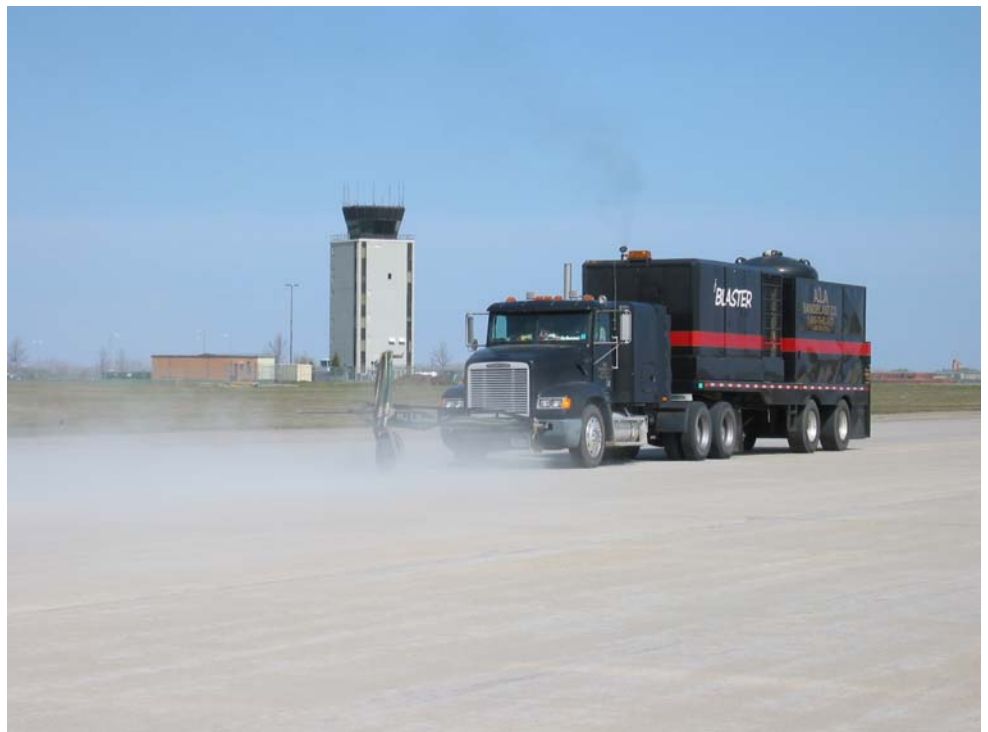
Sandblaster Removing Taxiway Markings for Conversion to a Temporary Runway

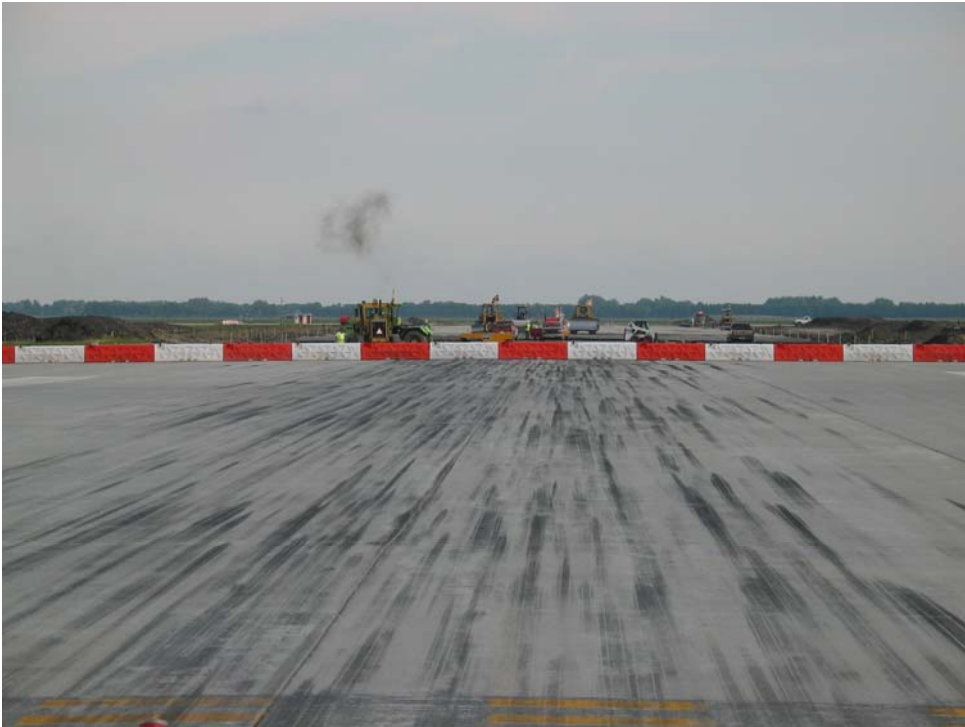
- Water-filled barricades across any pavement that linked the work site to the active airfield.

Water Filled Barricades

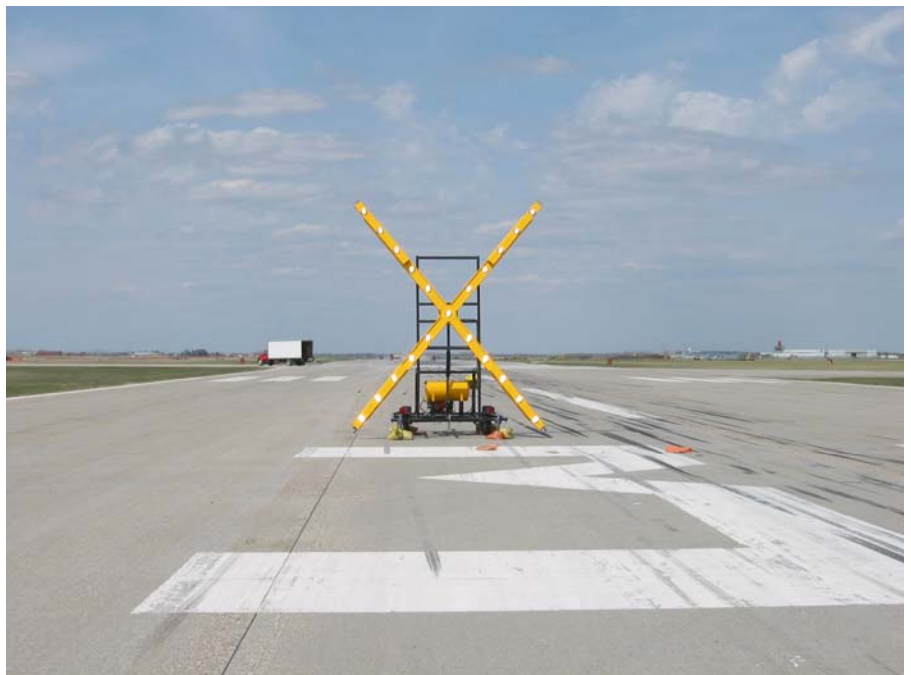
- Fencing around the entire work site that tied into the water-filled barricades, indicating the perimeter of the work site.
- Lighted yellow X's on the closed runway to alert pilots that the runway was not open.
- Construction access gates closed or guarded during work hours to keep errant vehicles off of the work site.
- Flashing beacons or flags on every vehicle on the site.

Runway Closure Marking

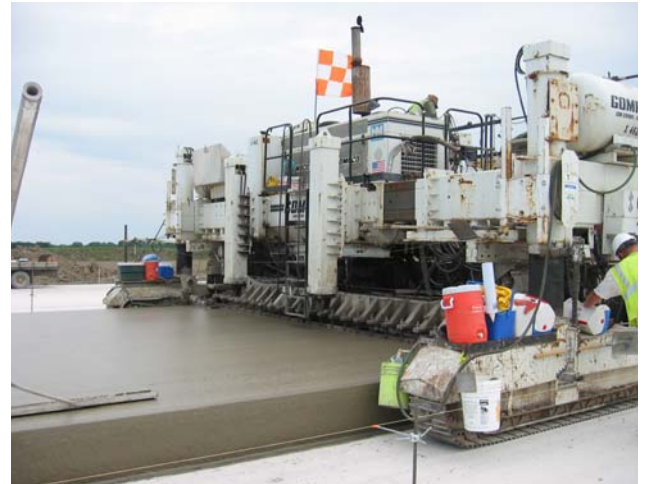
Smooth Paving on a Stable Platform

These layers acted together to provide a smooth, stable paving platform.

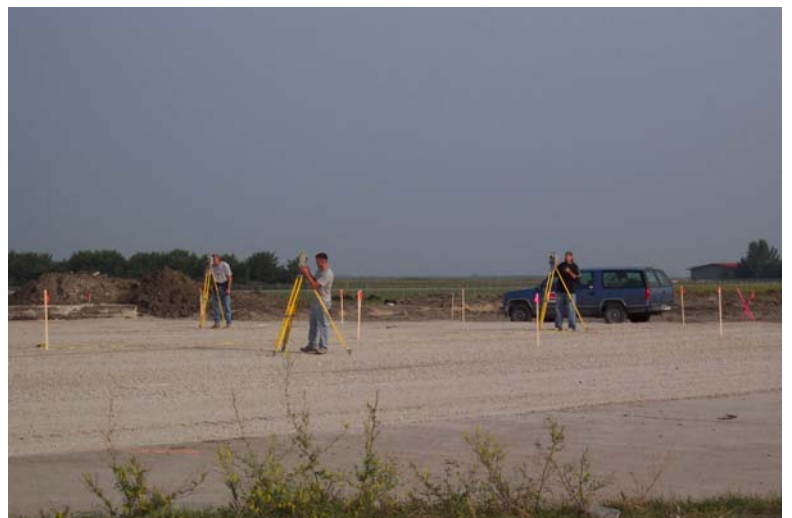
Surveyors set stringline hubs at every transverse joint line (25'). This allowed the hubs to be used to set the stringline and to mark for sawing. To stay ahead of Shafer's schedule, there were often six survey crews staking at one time.

Ulteig Survey Crews Setting Stringline Hubs

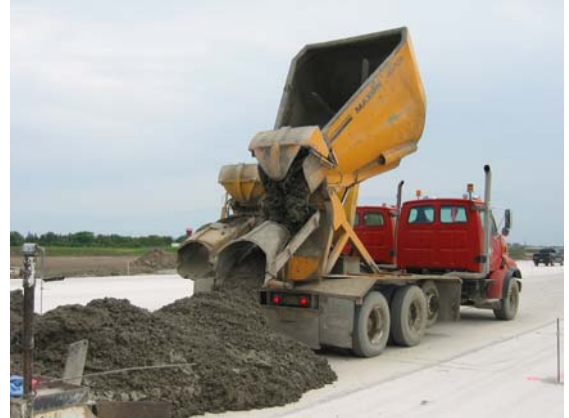
Shafer Contracting strategically erected a portable concrete batch plant in the plant site. The plant was a Rex Model S double-drum that produced 8 CY/min. To keep up with the huge cement demand of batching that much concrete, the plant was set up so that cement trucks could discharge into the plant while the plant continued to produce concrete. The concrete was hauled to the paver using end-dump and Agitor trucks.

Agitor Trucks Placing Concrete

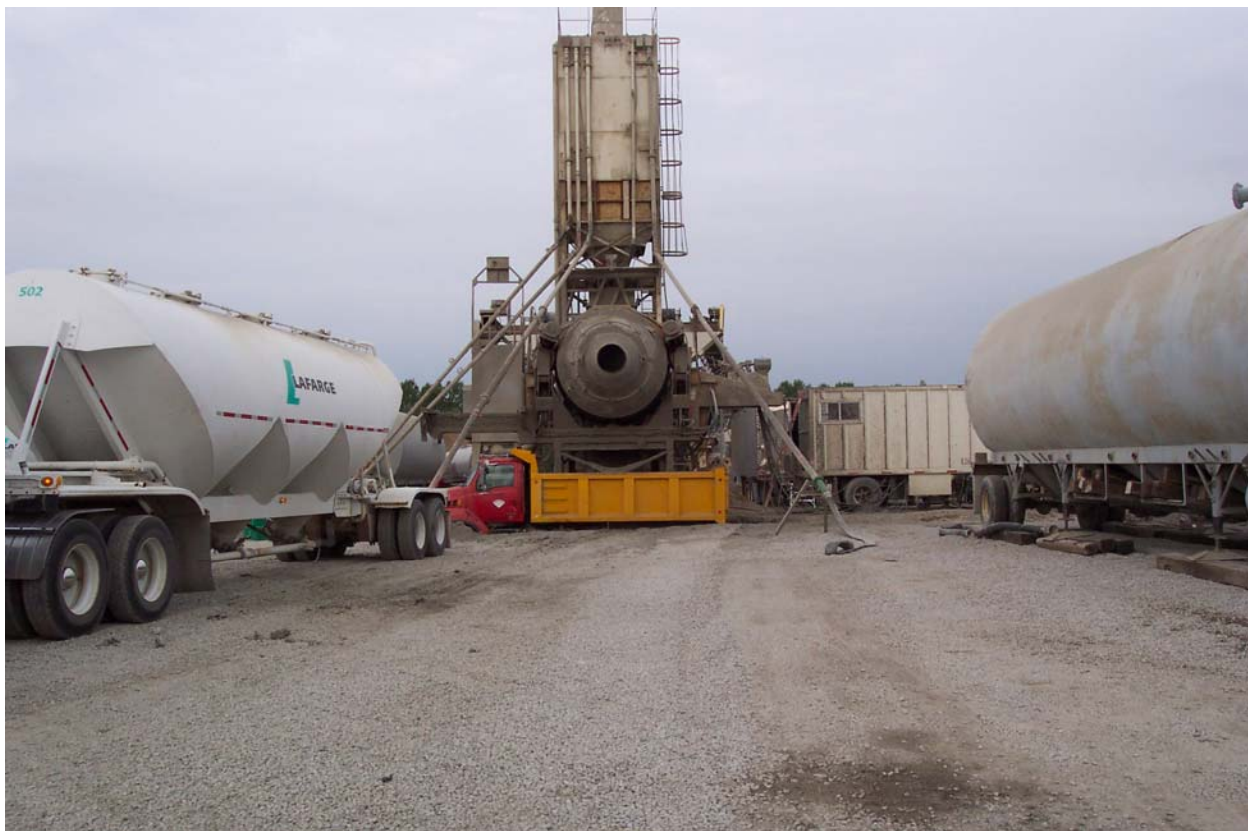
Double Drum Batch Plant

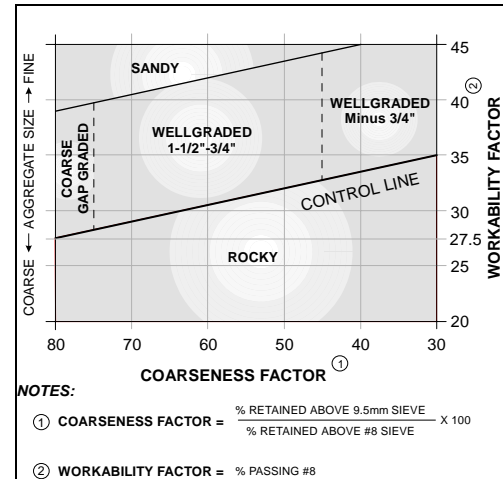
- Well-graded aggregate was specified for the concrete mix, utilizing the aggregate proportioning guide. This guide helps predict the physical properties of the mix by plotting the coarseness and workability factors.
- The existing concrete runway was crushed and recycled for use as the base and as the aggregate in the econocrete.
- Maturity monitoring was allowed in the specification to help the contractor maintain the project schedule.
- Shafer Contracting batched and placed econocrete in their yard prior to mobilizing to the jobsite to gain familiarity.

Aggregate Proportioning Guide

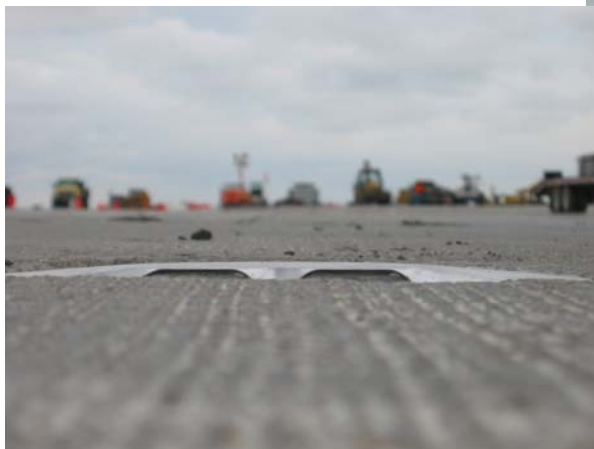
By placing the adjacent lanes first, the height of the light bases was set using a straightedge or stringline pulled across the open lane. This resulted in a perfect height for the finished lights.

Perfect In-Pavement Light Installation

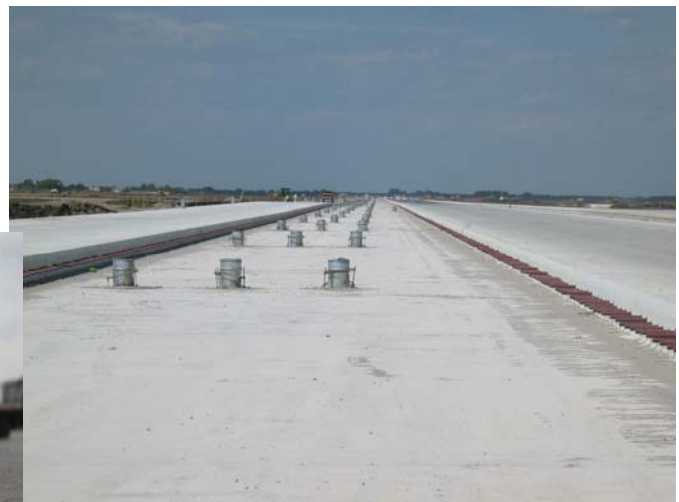
Touchdown Zone Light Bases Ready for Paving

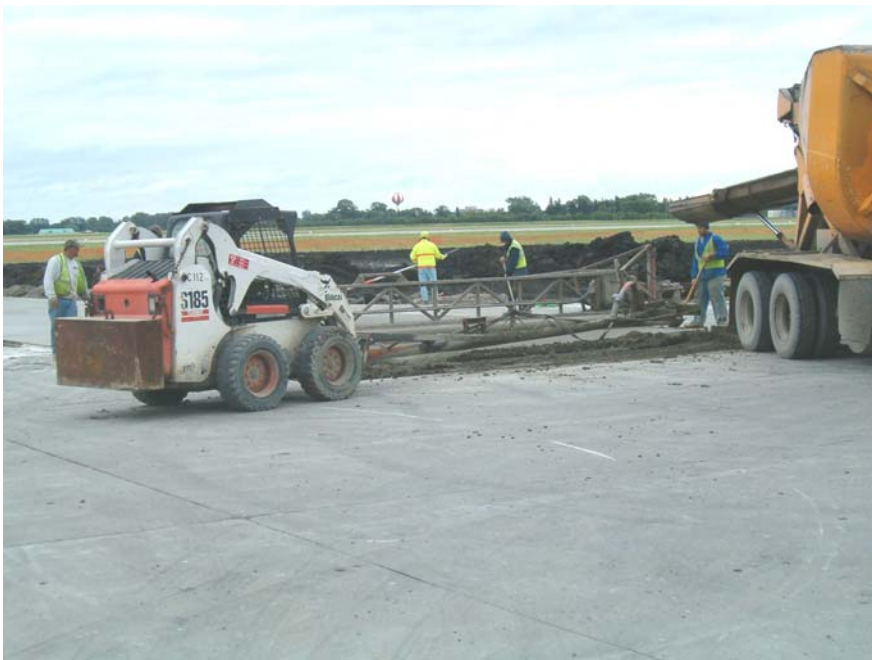
Boom-Mounted Vibrator

- The contractor used a specially fabricated, boom-mounted vibrator on a skid steer during hand-pours to reduce foot traffic in the concrete and reduce the time required to place and finish the concrete.

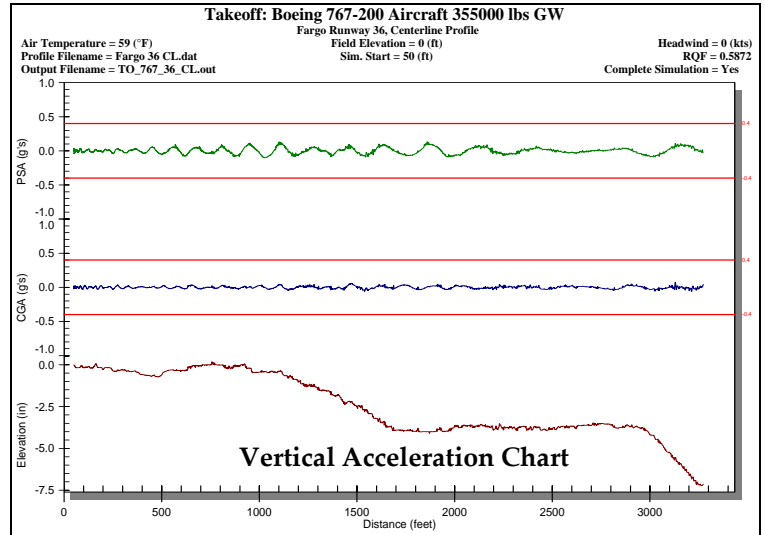
This chart (at right) shows the vertical acceleration at the pilot's seat (top) and the center of gravity (middle) as a Boeing 767 departs along Runway 36 profile (bottom). The red lines above and below the acceleration graphs are the thresholds where humans feel a sensation. The smoothness of the runway is evident in this graph because neither of the top two graphs approaches the sensation threshold of the red lines. No corrective measures were necessary to bring the aircraft ride within acceleration thresholds. This was one of the smoothest runways that APR Consultants have ever tested.

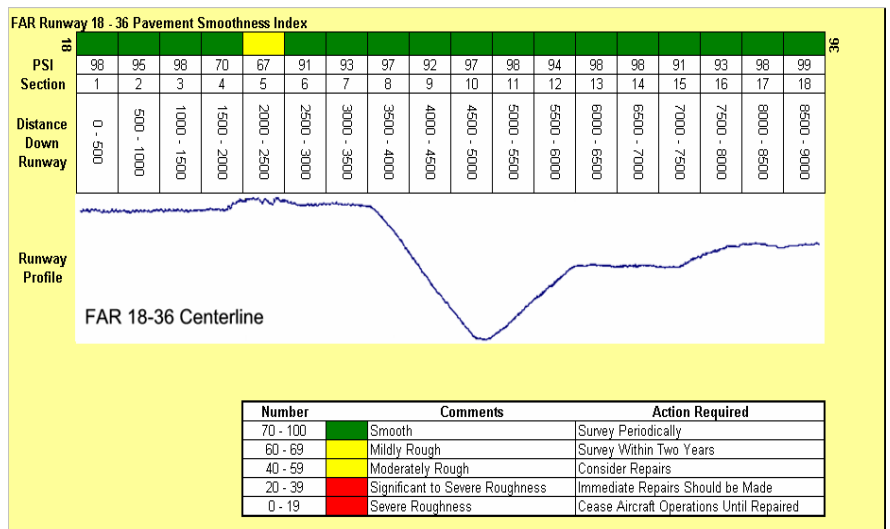
Pavement Smoothness Index Chart

According to the analysis performed by APR Consultants, the average pavement smoothness index (PSI) was 92.6. The PSI for each 500-foot section of runway is shown in the chart below. Section 5 was the existing crosswind runway that was not reconstructed.

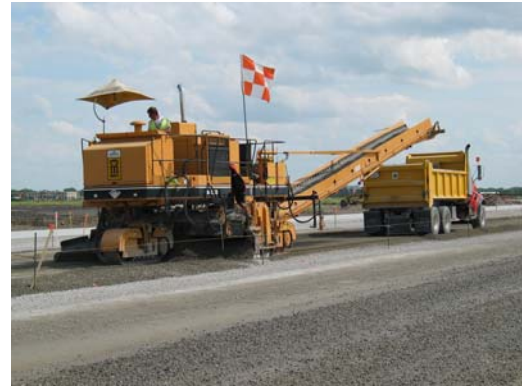
Trimming Aggregate Subbase

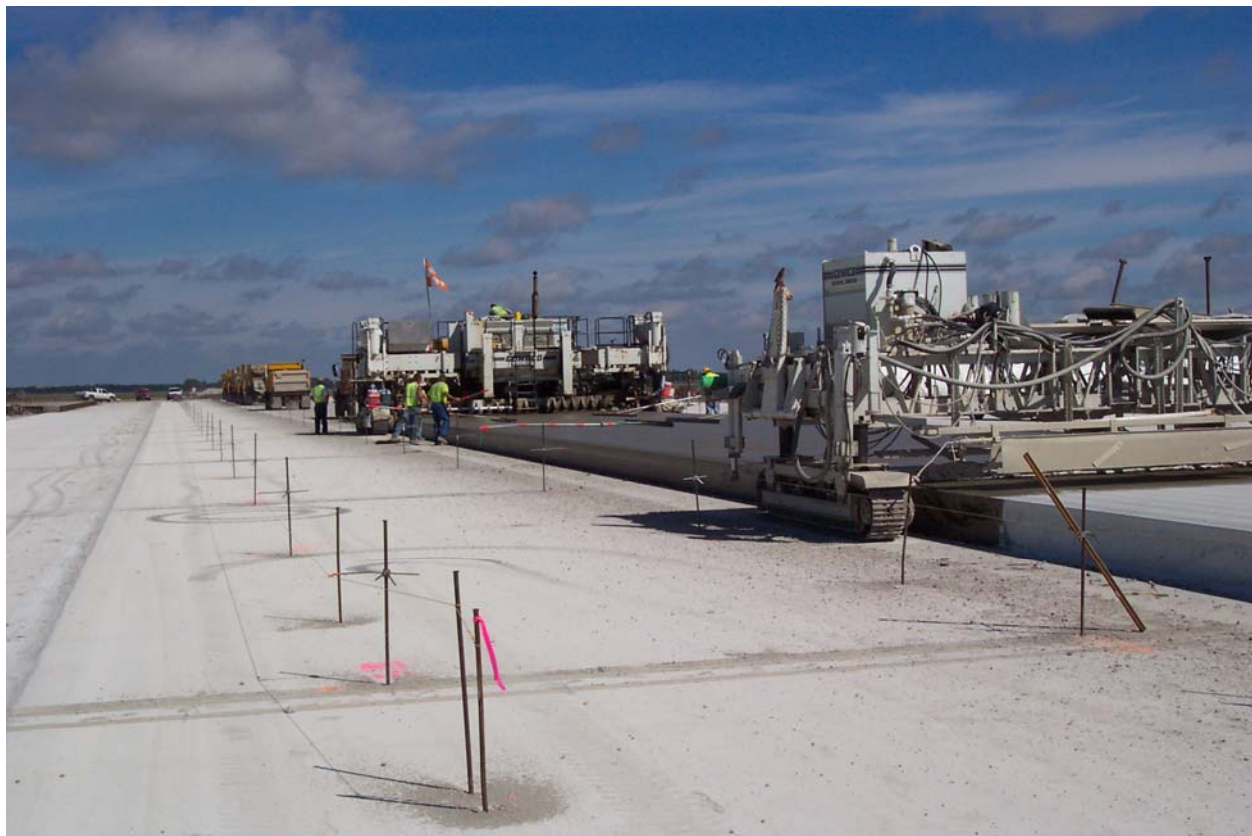
Smooth Paving with Consistent Concrete that was Compatible with Shafer's Equipment

This consistent mix was an important tool in ensuring the smoothest of ride performance in the new pavement. The mix was so consistent that no edge slump boards were required at any time. In addition, finishing effort after the paver was minimal.

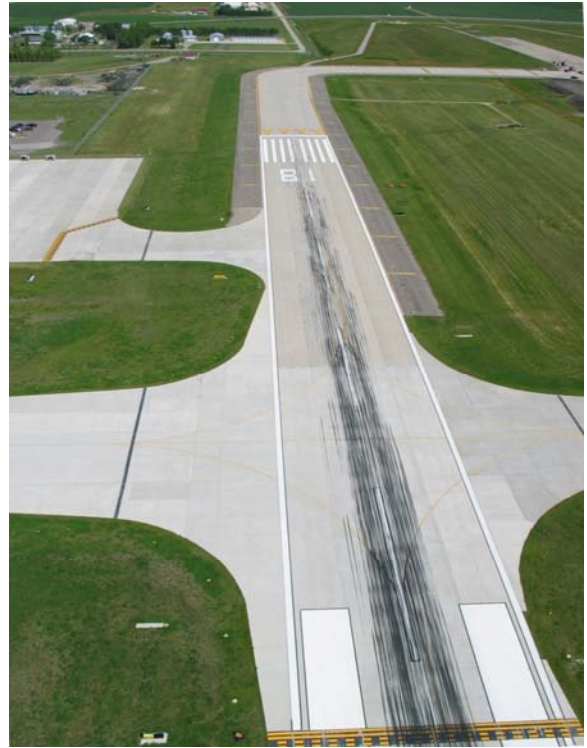
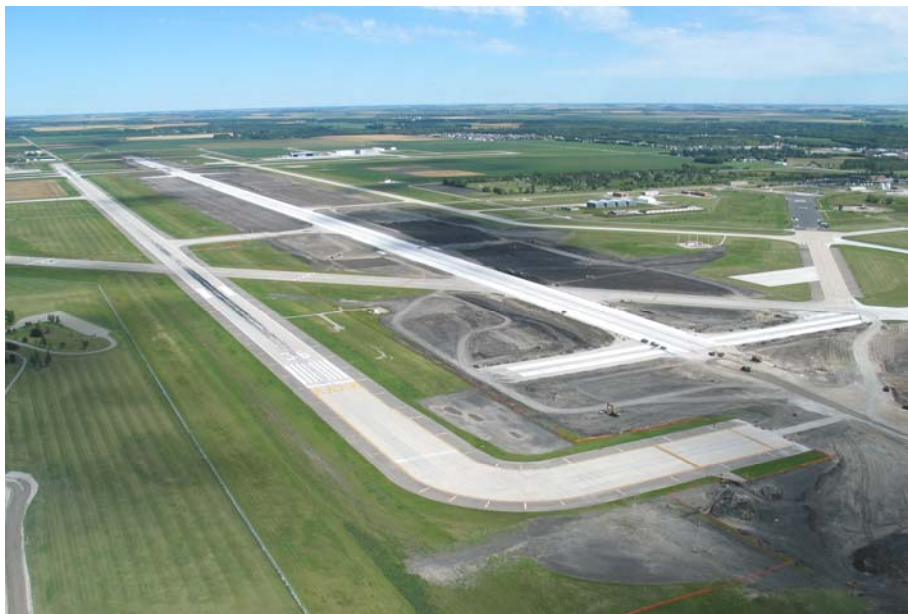
Taxiway A was converted to Temporary Runway 18-36 (100' x 8000') with full safety areas. At each end of the runway, an aircraft turnaround area was marked on the existing 115' wide crossover taxiways. A-320's regularly utilize the airport, however the airlines did not feel comfortable having them use the turnaround area, therefore the size of aircraft was limited to a DC-9.

Taxiway A Converted to a Runway

Taxiway A Converted to a Runway... at Left

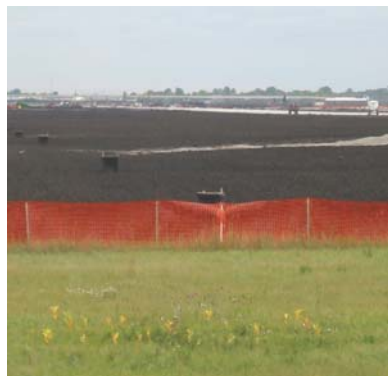
Orange Plastic Fence

- ➔ Use of Taxiway A as Temporary Runway 18-36
- ➔ NOTAM's (Notice to Airmen) informing pilots of temporary airfield changes
- ➔ Airfield Pavement Maps
- ➔ Lighted runway closure markings
- ➔ Water filled barricades separated open pavements from work zone
- ➔ Orange plastic fence delineated work area from active airfield

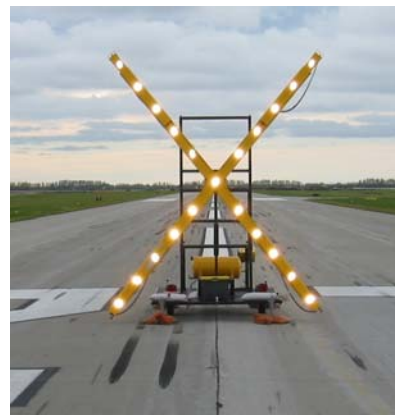
Lighted Runway Closure Marking

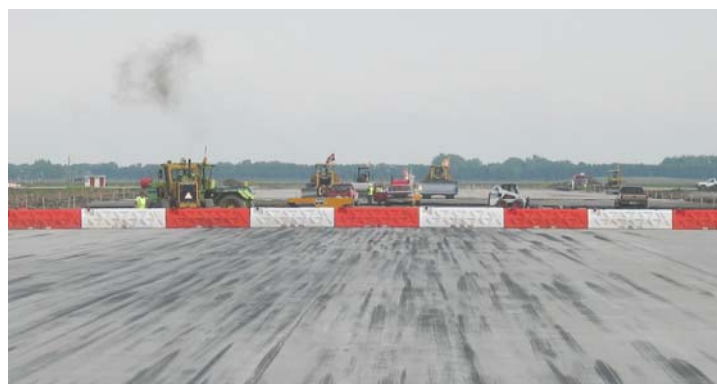
Water-filled Barricades

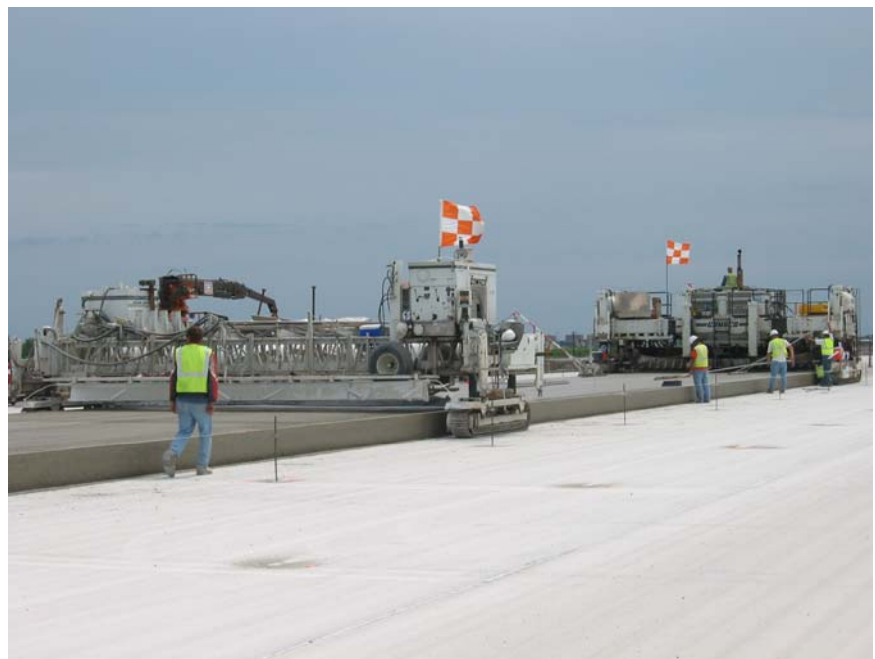
Ulteig had experience in the past with concrete that met every specification, but still had durability problems within the first year. This was largely attributed to mix incompatibility problems and overfinishing. To enable the contractor of this project to avoid those problems, the technology of well-graded aggregates was implemented. To utilize this technology Ulteig Engineers requested a Modification to Standards from FAA. The innovation paid off. Shafer Contracting developed a mix design with Midwest Testing Laboratory that flowed through their paver, filled all of the voids and held a vertical edge behind the paver without exception.

Smooth Paving with Well-Graded Aggregate Mix

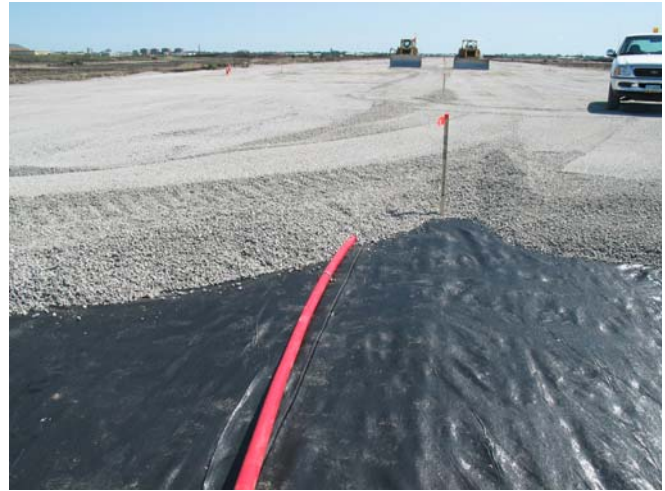
To avoid interference with construction equipment and to ensure the accuracy of the installation an extra deep light base was used. This placed the conduits in the crushed aggregate base layer. The contractor installed blockouts at each light location for the econcrete pave and excavated each blockout after the econcrete cured.

Conduit for Centerline Lights

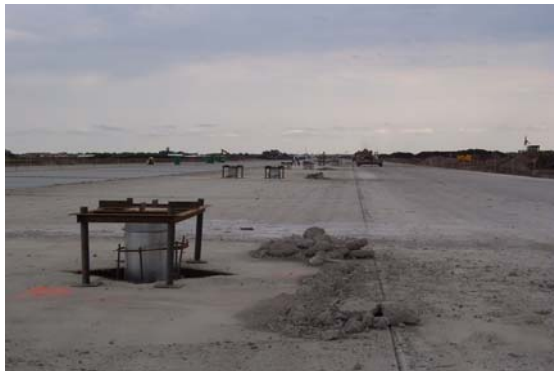
The conduits were cut and fit into the base and the base was set with concrete while being held in place with a jig. This system held the bases in the proper position during paving and resulted in a near 100% accuracy of light base placement.

In-Pavement Light Bases Held Securely with Alignment Jigs

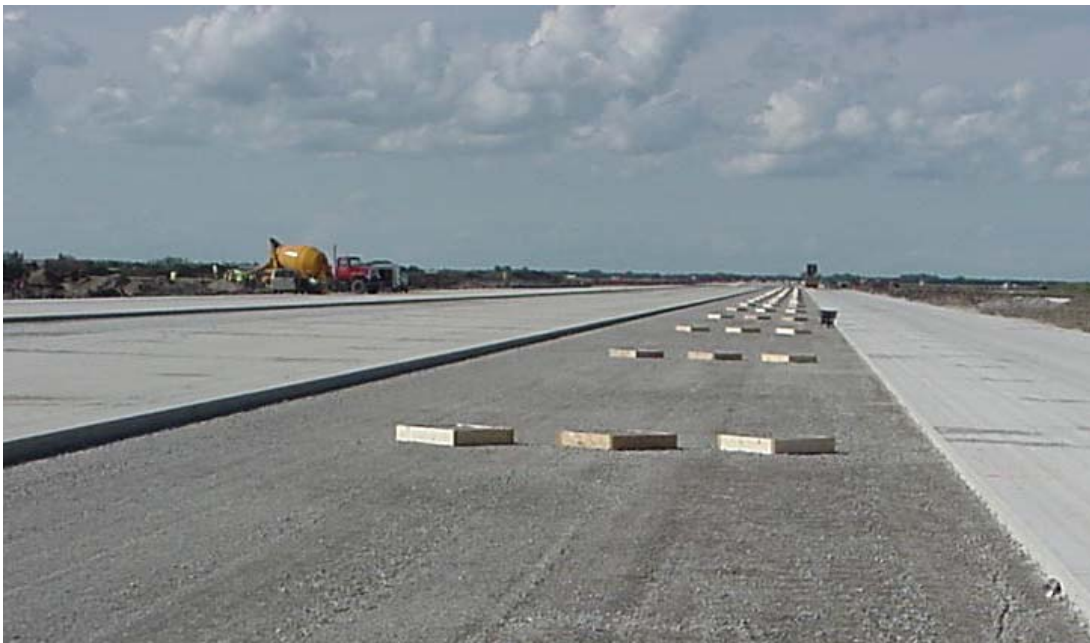
TDZ Light Blockouts

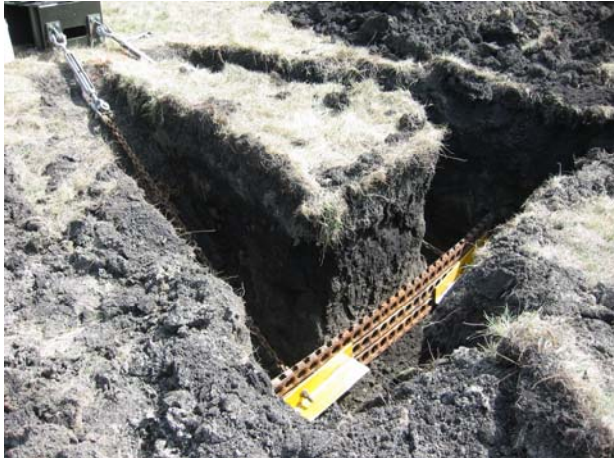
Ground Anchor for Temporary Barrier

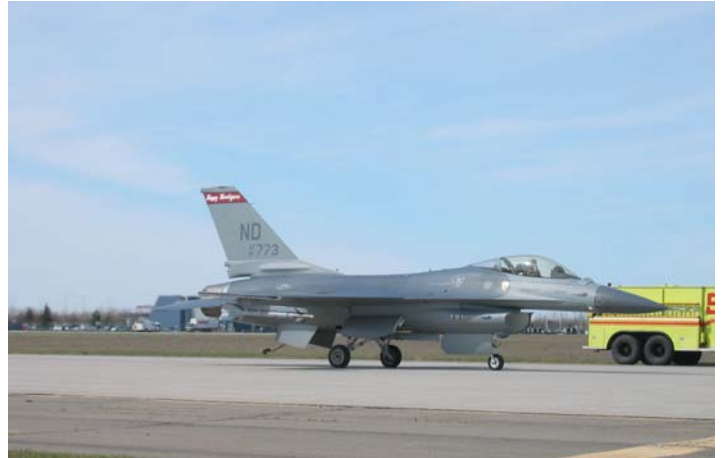
F-16 Testing Temporary Barrier

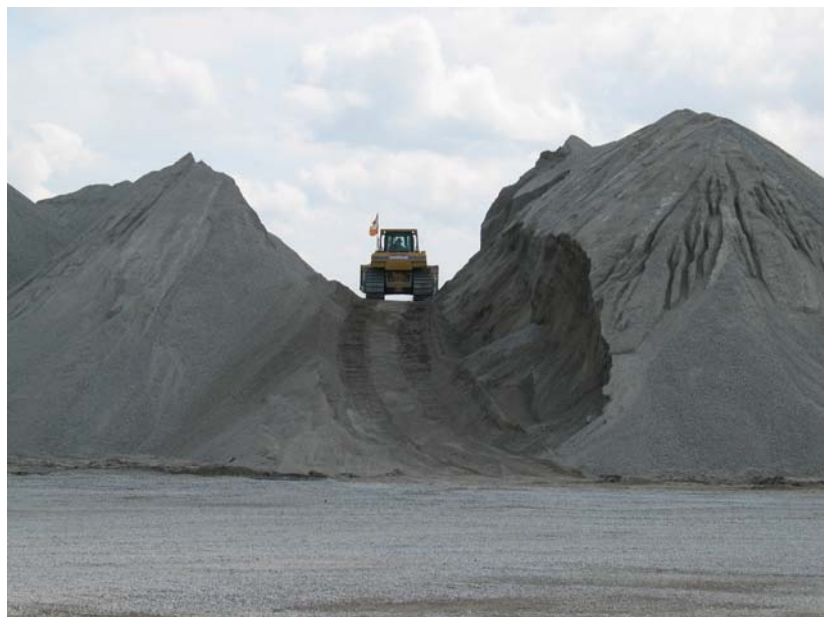
To utilize the vast resource in the old runway, the concrete was crushed and used as a crushed aggregate base and as aggregate in the econocrete.

The crushed aggregate base course was placed and trimmed like any aggregate base, but the econocrete required extra testing and monitoring by Shafer's QC staff to maintain consistent moisture contents due to the materials absorptive qualities.

Crushed Concrete Stockpile

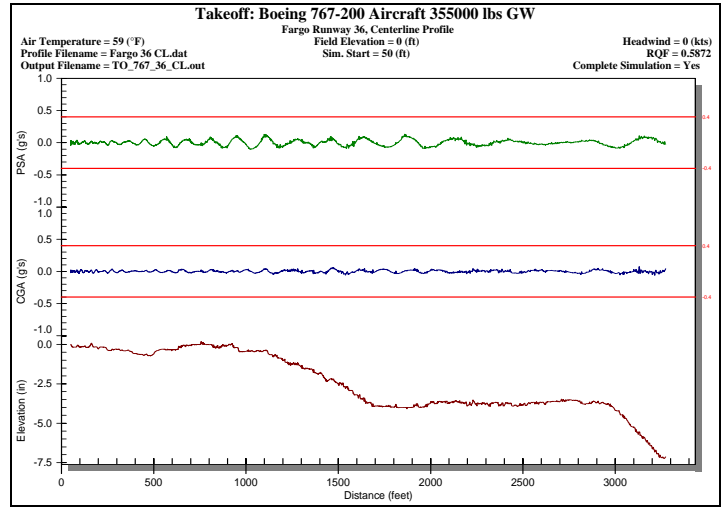
long as most commercial aircraft. To determine an aircraft's response to the pavement, the Engineer subcontracted an aircraft ride analysis with APR Consultants. An aircraft ride analysis measures the profile of the runway and simulates subject aircraft on that profile in takeoff conditions. The analysis gives vertical accelerations at both the pilot's seat and the center of gravity of the aircraft.

The vertical accelerations on this project were all well within the smooth rating.

Smoothness Graph

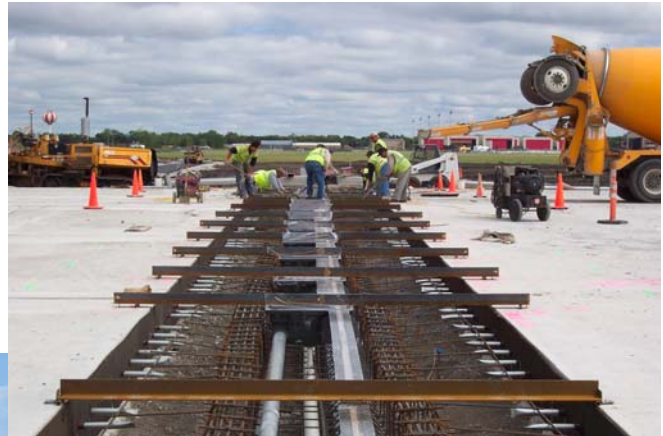
Placing Concrete for the South Arresting Barrier

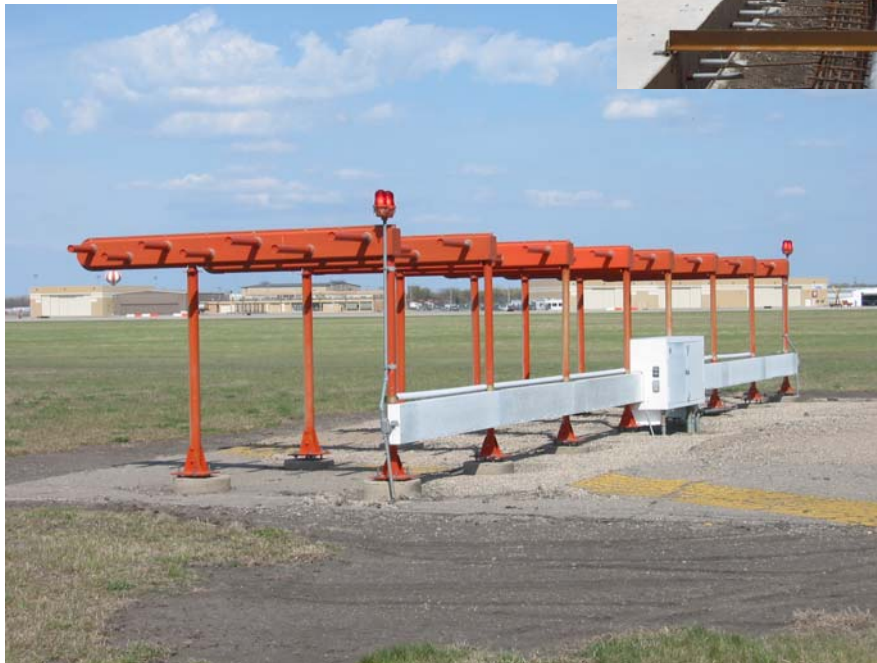
Localizer Antenna Array
